# Intake Tunnel Investigation Report

SeaView Systems' Report on the January 2009 Visual and Profiling Sonar Investigation of the Main Intake Cooling Tunnel accessed from shore.

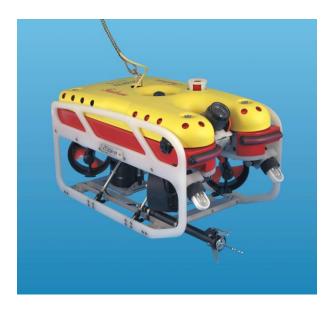
Seaeye Falcon DR ROV

The investigation was performed using SeaView Systems, Inc.'s Seaeye Falcon DR ROV. This system uses fiber optic technology, SeaView Systems 6000' fiber optic umbilical/spool system and an in-house developed surface power supply system to enable us to perform very long distance tunnel and pipeline penetrations while recording a large amount of video and sonar data.
